NASA Technical Memorandum 85652

FACTORS INFLUENCING AIRCRAFT GROUND HANDLING PERFORMANCE

T. J. Yager, Aero-Space Technologist
NASA Langley Research Center
Hampton, Virginia

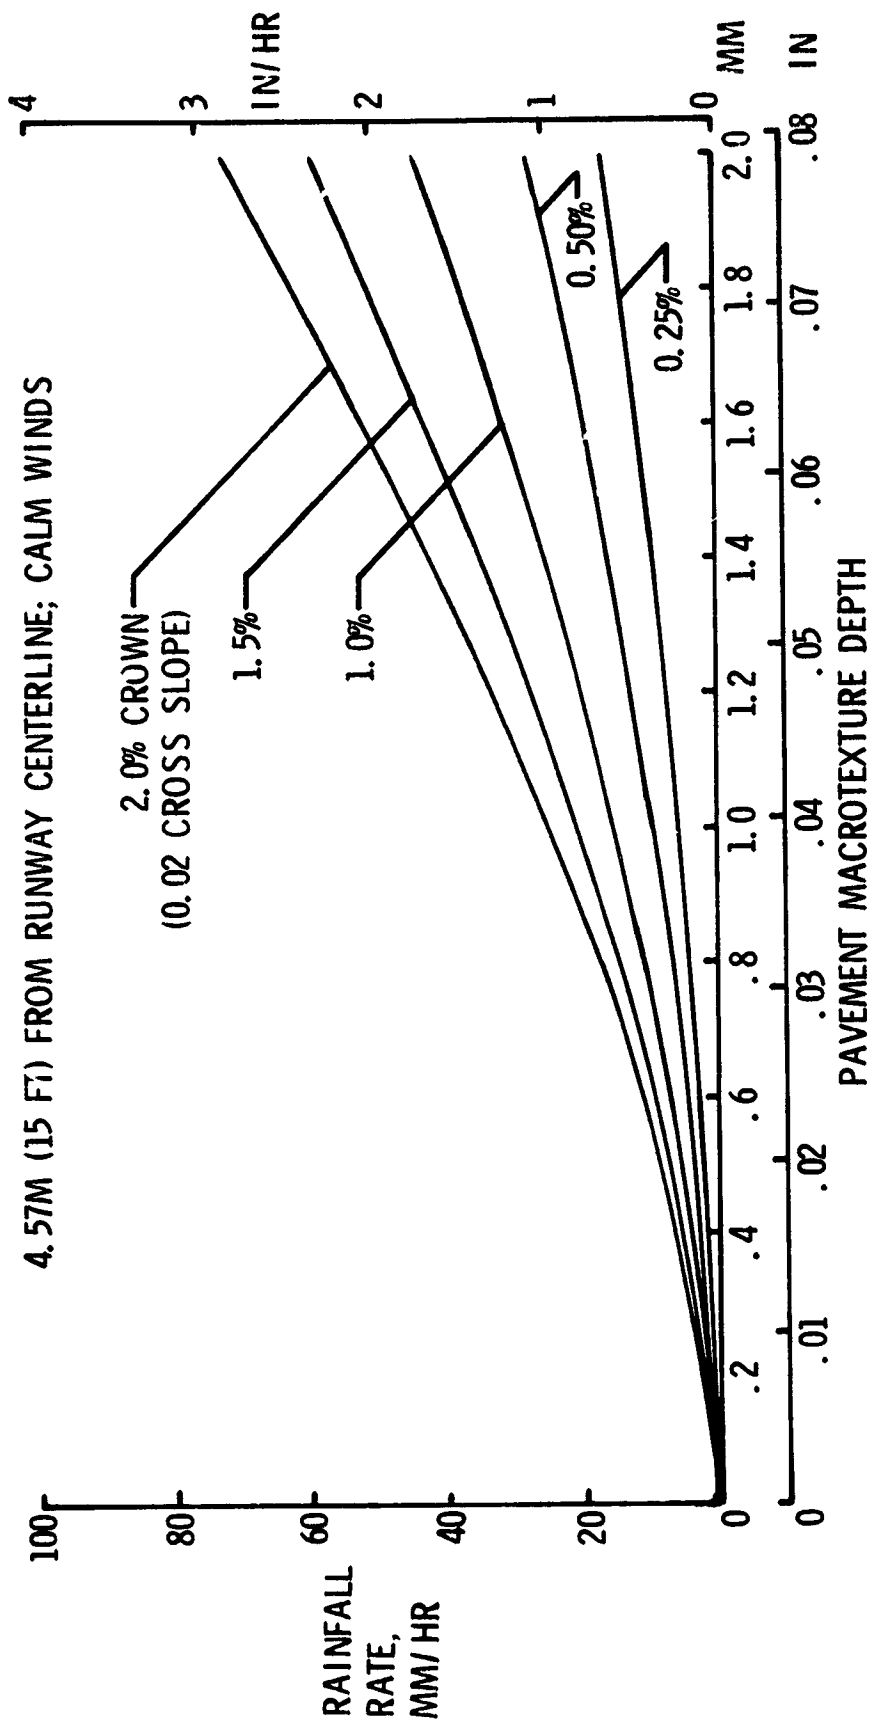
Figure 2.- Calculated rainfall rate required for flooding runway surfaces in typical transport aircraft main gear tire path.

$$\text{RAINFALL RATE} = K \left[\frac{(\text{MACROTEXTURE DEPTH})^{.89}}{(\text{DISTANCE FROM RUNWAY } \text{E})^{.43} \left(\frac{1}{\text{CROSS SLOPE}} \right)^{.42}} \right]^{1.695}$$

(FROM REF. 10)

WHERE:

K = 1253 for metric units; 15430 for U.S. Customary units

The data shown in figure 2 represent the calculated variation in rainfall rate required to flood to within 4.57 m (15 feet) of the runway centerline. The main gear tires of a B-767 transport airplane would be near this distance from the runway centerline if the airplane was traveling directly down the centerline. Calculations were made for five different cross slopes each having a similar range of macrotexture depths. In general, the figure shows

the increase in rainfall rate needed to flood the surface as a function of cross slope and macrotexture depth. If the depth of pavement macrotexture is small, such as observed in some rubber-coated runway touchdown areas, rainfall intensity required for flooding is low despite appreciable cross slope values. Similarly, the chance of reaching flooded surface conditions for a given rainfall intensity increases with decreasing cross slope. In addition, it can be shown that as the distance from the runway centerline (apex of crown) increases, lower rain rates may produce surface flooding.

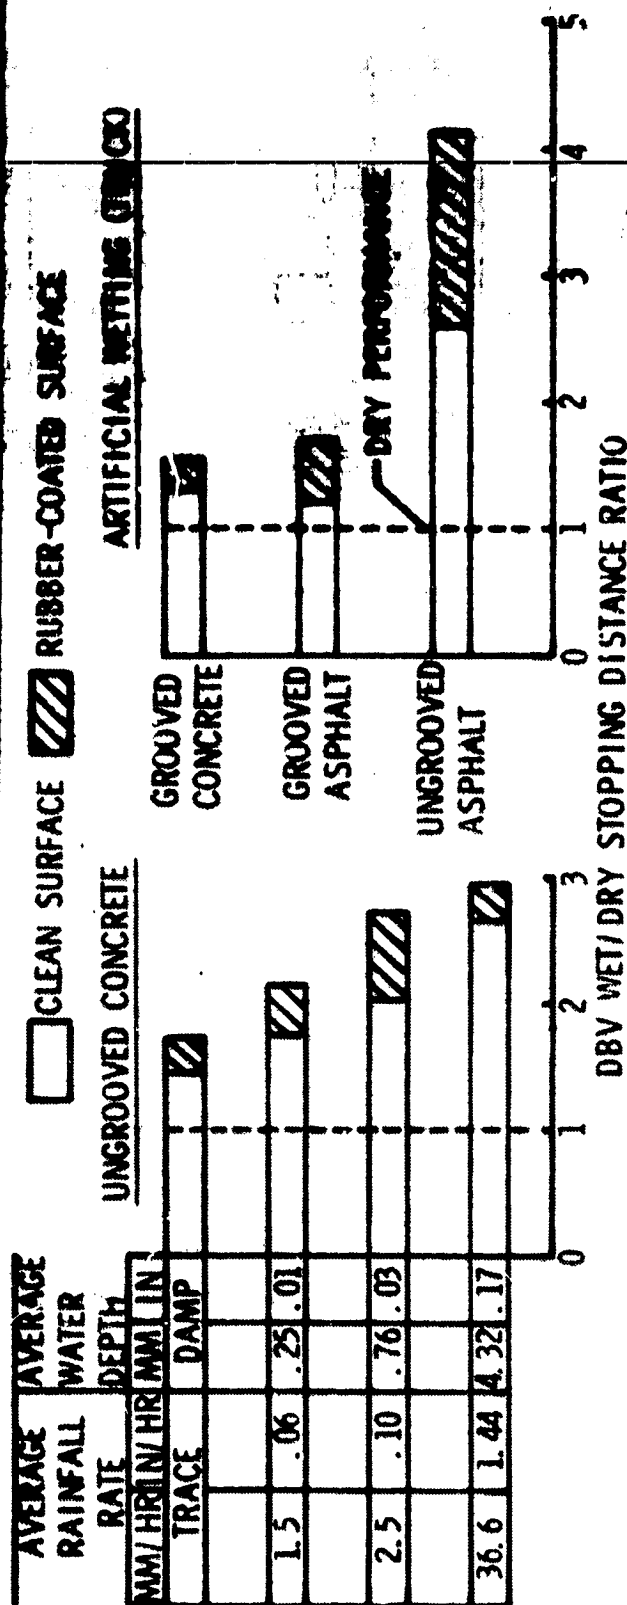
Figure 5.- Effect of surface contaminants on diagonal-braked vehicle stopping performance.

The effect of surface water and rubber contaminants on vehicle stopping capability and tire friction performance is shown in figure 5. This evaluation was performed with the NASA-developed diagonal-braked vehicle (DBV) shown in the photograph in figure 5. The brake system diagram illustrates the modification made to implement stable and controlled vehicle performance during the friction measurements at high speed with two diagonal wheels locked and the remaining pair free rolling (unbraked). The DBV wet/dry stopping distance ratios depicted in the bar graphs for different rainfall

rates and surface types were obtained from test runs conducted at the same distance off runway centerline with brake application speed from 98 km/h (60 mph) down to a complete stop. Measurements of surface water depth and

DBV stopping distance during different periods of rainstorm activity on an ungrooved concrete runway with a 1 percent crown reveal a direct relationship between average water depth and stopping distance. As rainfall rates increase, greater water buildup on the runway surface occurs which decreases tire friction performance as reflected in the increased DBV wet/dry stopping distance ratios. A further increase in runway slipperiness was found near the end of the runway which was contaminated by rubber deposited during aircraft tire spin-up following touchdown. The buildup of the rubber coating on runway surfaces tends to reduce pavement texture and hence, degrade tire friction particularly under wet conditions. The cross-hatched DBV stopping distance increment shown in figure 5 illustrates the effects of rubber contamination on the ungrooved concrete runway slipperiness measurements for different rainfall rates. Also included in the figure are comparable DBV measurements made on other grooved and ungrooved runways under artificially wetted (truck) conditions where the average water depth was 0.5 mm (0.02 in.). The longer DBV wet/dry stopping distance ratios measured on the ungrooved asphalt runways compared to the concrete surfaces are the result of lower surface macrotexture. Fortunately, successful methods ³¹ have been developed to remove the rubber deposits on runway surfaces using high pressure water and now many major airports regularly schedule runway rubber removal treatments.

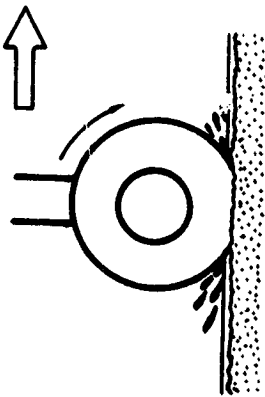
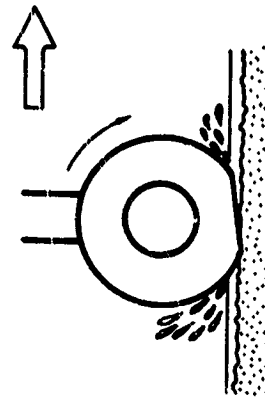
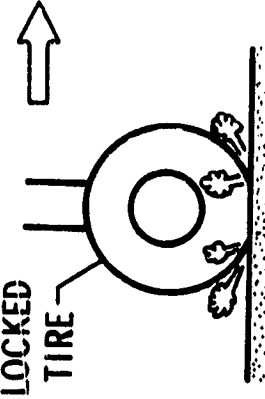
Figure 5.- Principal causes of wet pavement tire friction losses.

CAUSES	HYDROPLANING			REVERIED RUBBER SKIDDING
	VISCOUS	DYNAMIC

CONTRIBUTING FACTORS	DAMP OR WET PAVEMENT MEDIUM TO HIGH SPEED POOR PAVEMENT TEXTURE WORN TIRE TRFAD	FLOODED PAVEMENT HIGH SPEED LOW TIRE PRESSURE WORN TIRE TREAD	WET OR FLOODED PAVEMENT HIGH SPEED POOR PAVEMENT TEXTURE DEFICIENT BRAKE SYSTEM	
	PAVEMENT MICROTEXTURE PAVEMENT GROOVING GOOD TREAD DESIGN	PAVEMENT MACROTEXTURE PAVEMENT GROOVING INCREASED TIRE PRESSURE GOOD TREAD DESIGN	GOOD PAVEMENT TEXTURE PAVEMENT GROOVING IMPROVED ANTISKID	
ALLEVIATING FACTORS

The principal forms of these wet pavement tire friction losses, namely, viscous and dynamic hydroplaning and reverted rubber skidding, are illustrated in figure 6. The speed regime, pavement and tire condition, and tire operating mode that contribute to loss in tire friction are identified together with the factors that tend to alleviate their occurrence. Viscous hydroplaning or thin-film lubrication results from the inability of the tire to penetrate and disrupt the very thin residual fluid film left on the pavement after the majority of the trapped water has been displaced from the tire footprint. In this case, the pressure buildup within the tire/pavement interface is due to fluid viscous properties. Smooth tires operating on wet smooth pavements are particularly susceptible to this type of tire hydroplaning.

During dynamic hydroplaning, a buildup of hydrodynamic pressure between tire and flooded pavement occurs as the square of vehicle speed. ² When this hydrodynamic pressure exceeds the tire-pavement bearing pressure, a wedge of water penetrates the tire contact area and the tire footprint is partially or totally detached from the pavement surface. Under total dynamic hydroplaning conditions, tire friction capability is reduced to near zero because of the inability of the fluid to support significant shear forces. It should

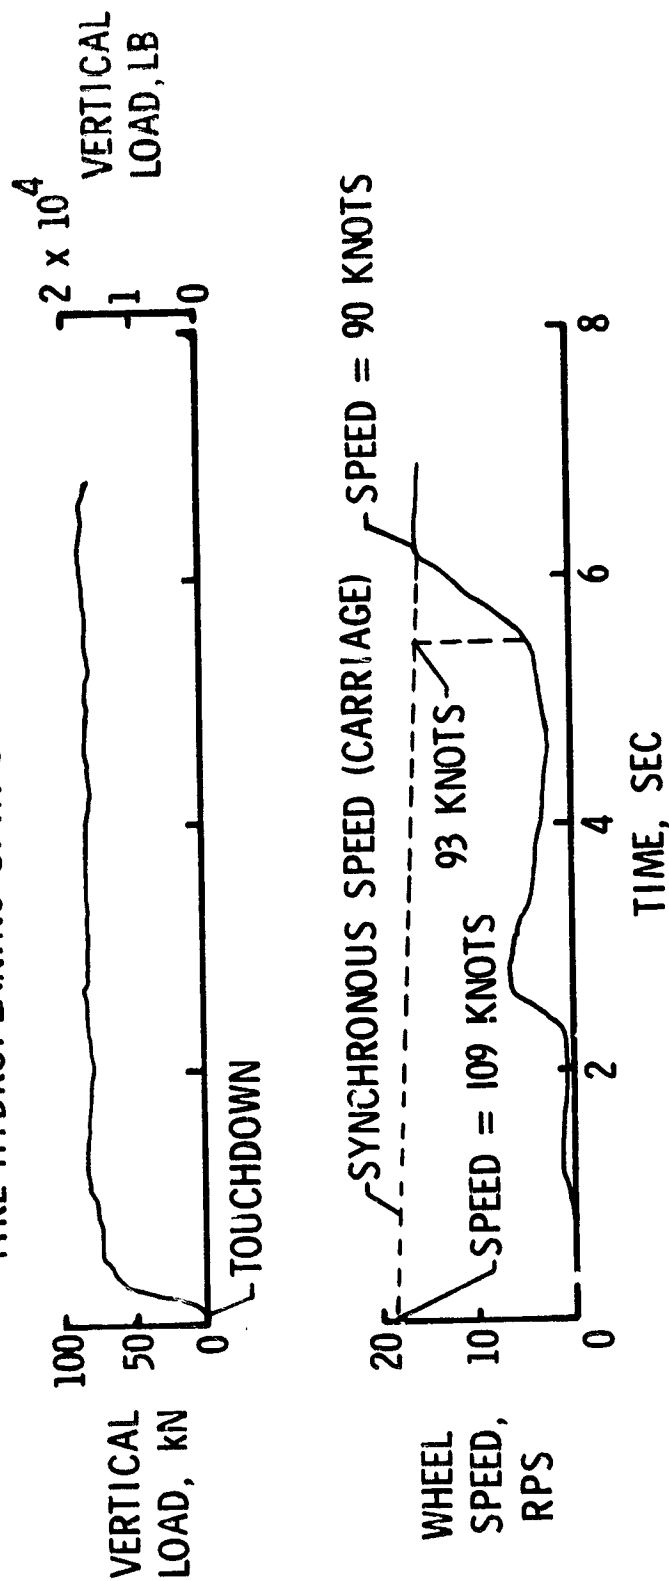
Figure 7.- Delayed wheel spin-up at touchdown on flooded runway test surface at Langley track facility.

DC-9 MAIN GEAR, RIB-TREAD TIRE; INFLATION PRESSURE, 965 kPa (140 LB/IN.²)
 AVERAGE WATER DEPTH, 5 MM (0.2 IN.)

TIRE HYDROPLANING SPIN-UP SPEED = 91 KNOTS

For the nonrotating tire case (as at aircraft touchdown), Langley track test results shown in figure 7 illustrate the delay in tire spin-up following touchdown on a flooded surface until the test carriage speed decreased to approximately 93 knots. It is important that pilots be aware that the lower hydroplaning spin-up speed, rather than the high hydroplaning spin-down speed, represents the actual tire situation for aircraft touchdown on flooded runways.

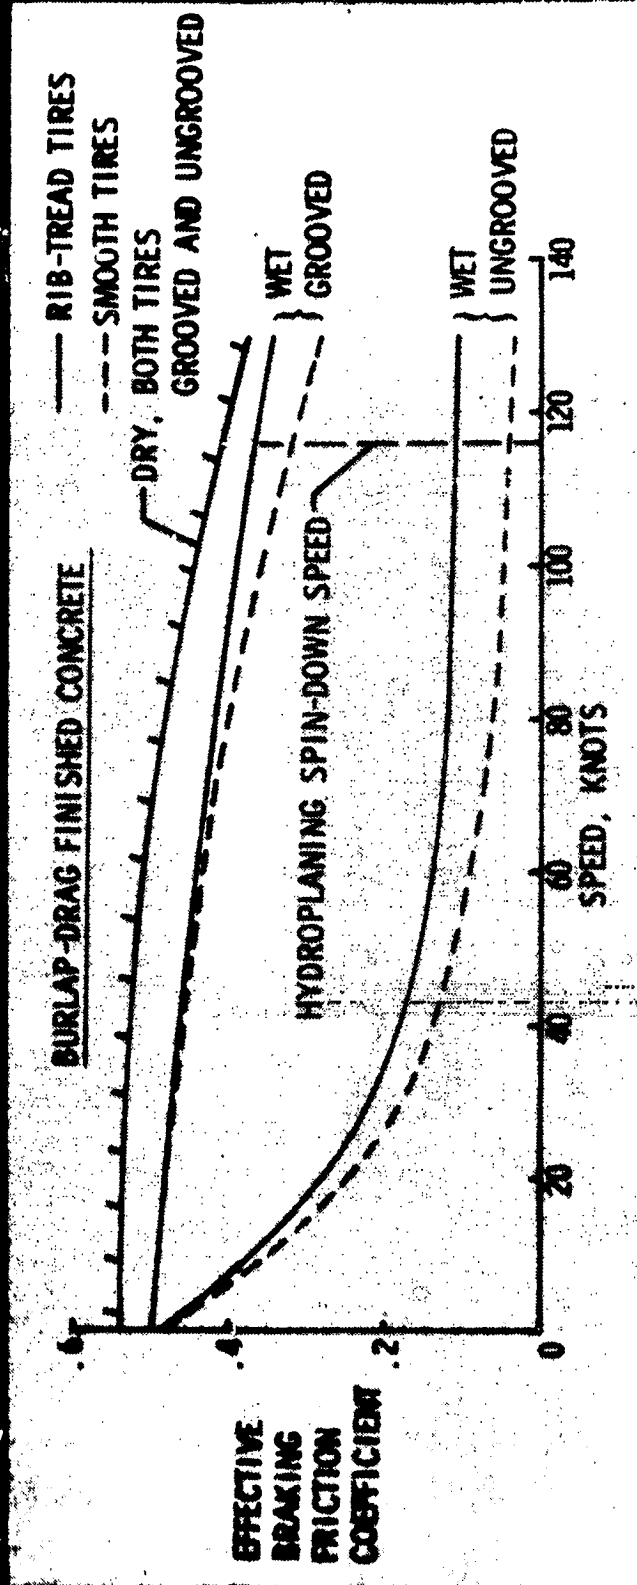
Figure 9.- Effect of tire tread design and pavement surface condition on CV990 aircraft braking friction.

During aircraft ground operations, pilot techniques and control inputs together with certain aircraft parameters including aerodynamics, engines, brake system, and landing gear configuration interact to determine how much of the available tire pavement traction is utilized for stopping and directional control purposes. The influence of speed, tire tread condition, and pavement surface macrotexture on aircraft braking performance is illustrated in figure 9. These data were obtained during instrumented CV990 aircraft braking tests⁸ conducted at NASA Wallops Flight Center on a unique research runway which features a variety of pavements selected to provide a wide range of surface macrotextures. A portion of each of these different pavements was modified with installation of 6 x 6 x 25 mm (0.25 x 0.25 x 1-in. pitch) transverse grooves. For dry concrete conditions, the measured aircraft

effective braking friction coefficient level indicated in figure 9 did not vary significantly with tire tread design or surface configuration but some decrease was observed with increasing speed. The effect of speed was much more pronounced on the wet ungrooved surface and these data indicate that ~~the rib-tread design provided a significant improvement compared with the~~ smooth tire data. The calculated hydroplaning spin-down speed of 114 knots noted in figure 9 is based on a tire inflation pressure of 1103 kPa (160 lb/in²). On the similarly wetted grooved concrete, the transverse runway grooves produced substantially greater aircraft braking friction levels with both tire treads than were shown by the wet ungrooved surface data. These aircraft braking performance data on wet runways also suggest that the effects of tire tread wear are secondary to the effects of surface grooving because of the greatly enhanced tire/pavement water drainage capability available on grooved runways.

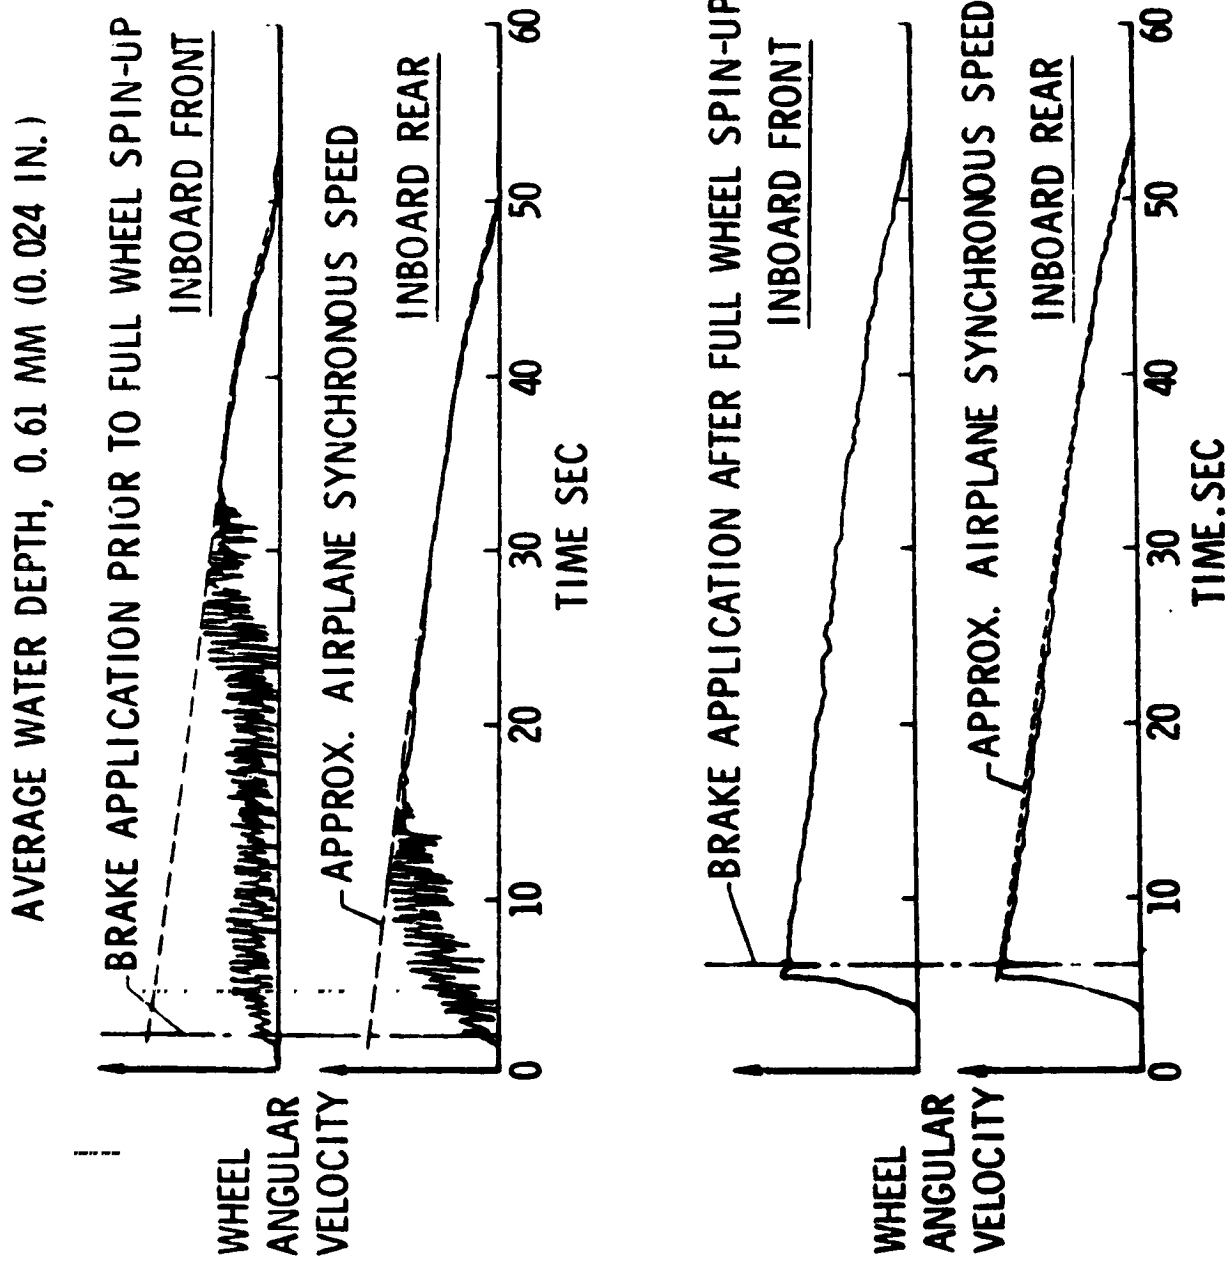
Figure 10.- Aircraft braked wheel responses for antiskid brake application prior to and after full wheel spin-up during landings on wet surface.

An example of such anomalous antiskid brake control operation following touchdown is given in figure 10. These time history data collected during wet runway tests with a large jet transport aircraft ³² illustrate the antiskid brake control response of the inboard wheels on a four-wheel bogie main landing gear to brake applications that occurred prior to and after full wheel spin-up during landings. For brake application prior to full wheel spin-up, it is apparent from figure 10 that the ground speed reference assumed by the skid-control logic circuit for the front wheel is well below the actual aircraft speed. The low wheel spin-up accelerations following brake pressure release during each braking cycle, combined with the low ground speed reference, prevented the front wheel from attaining synchronous aircraft speed until approximately 30 seconds into the landing rollout. By that time, the aircraft speed had decreased sufficiently to cause high wheel spin-up acceleration and the proper ground speed reference signal was acquired. Subsequently, braked wheel motion was satisfactorily controlled down to the aircraft stop point. The much faster recovery of aircraft synchronous speed

by the rear tandem wheel (Figure 10) reflects the benefit of path clearing by the front tandem wheel which produces a less slippery surface for the trailing wheel.

Figure 10 also includes wheel angular velocity data obtained during a second aircraft landing in which brakes were applied after the wheels reached full spin-up. These braked wheel responses suggest that the pilot should delay brake application during landings on wet runways to allow the skid-control logic system sufficient time to acquire an accurate ground speed reference. The considerably reduced tire skidding experienced during this landing compared to the data collected when brakes were applied early suggests improved aircraft stopping performance and reduced tire wear. It should be noted that a comparison of the braking effectiveness demonstrated by the two landings is not justified because the tests were made at different aircraft gross weights and brake application speeds.

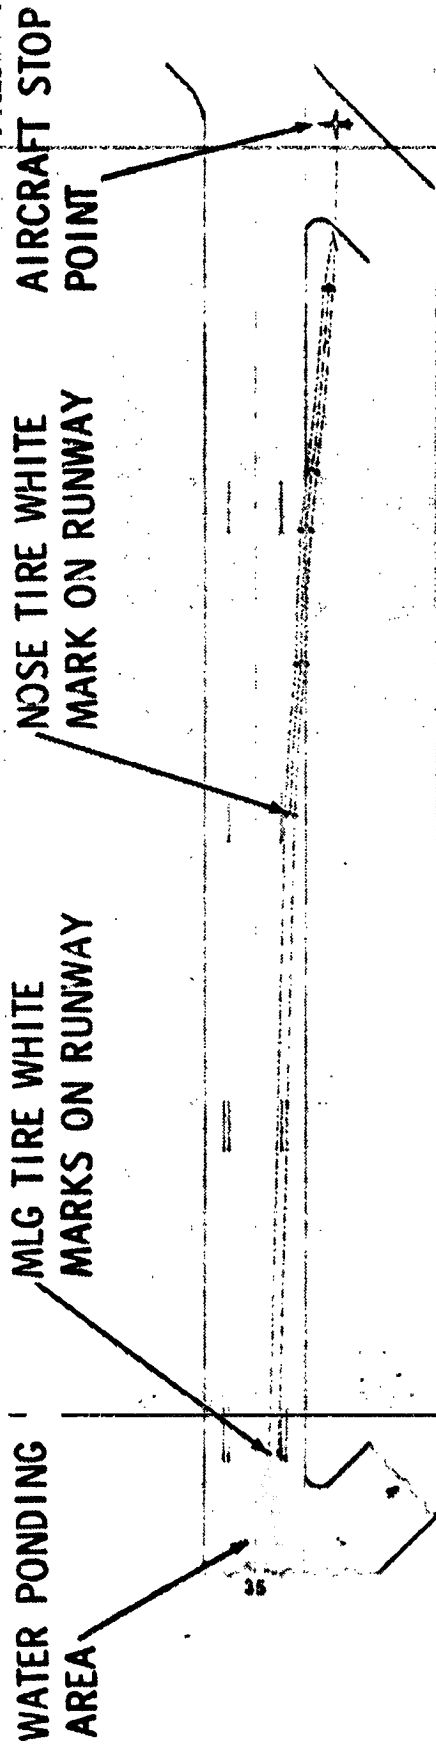
Figure 12.- Aircraft wet runway landing accident with reverted rubber skidding occurring without wheel brake application.

ACCIDENT AIRCRAFT RUNOUT TRACK

MLG TIRE TRACKS

RUNWAY SURFACE

SKID PATCHES ON MLG TIRES

DAMAGED AIRCRAFT

Additional insight into the lack of directional control as well as reverted rubber skidding caused by nonrotating tires was obtained during a recent investigation of a T-38 aircraft landing veeroff accident which occurred at night during a moderate rainstorm. A left-to-right crosswind component caused the pilot to land the aircraft at a crab angle slightly right of runway centerline. The accident aircraft landing runout track, identified by white marks visible on the runway surface, is shown in figure 12 together with photographs of the ungrooved, low textured (class V), concrete runway surface, the main landing gear (MLG) tire skid patches, and the damaged aircraft. Fortunately, the pilot escaped injury even though the nose and right main landing gear failed and the right wing tip was sheared off subsequent to the aircraft leaving the right shoulder of the runway, traversing a relatively soft soil surface, and coming to rest on an intersecting paved taxiway. During the investigation which followed the accident, the estimated aircraft touchdown point near the runway intersection was found to be a water ponding area with water depths measured up to 13 mm (0.5 in.). Additional evidence

and factors which tend to support the belief that possibly the MLG tires did not spin up following touchdown include the fact that the aircraft touchdown speed was significantly higher than the calculated tire hydroplaning spin-up speed of 119 knots, the surface white marks from the MLG tires commenced when the aircraft exited the deeply flooded portion of the runway and continued to the runway shoulder edge, and only one skid patch, showing evidence of tread rubber reversion in the aft portion, was found on each MLG tire. Knowing that he was landing on a wet runway, the pilot did not apply wheel braking during the aircraft runout on the paved runway and yet, reverted rubber skidding evidently occurred. Inspection of the aircraft wheel brake assemblies revealed no abnormalities and no indication of dragging brake operation. In all other documented aircraft accident/incident cases involving reverted rubber skidding, the pilot had employed wheel braking during the aircraft runout which contributed to locked wheel operation.
